Roland VS-1880 op-amp swap

There has been much talk at the VS-PLANET forum about the Roland VS op-amp swap modification, not to mention considerable discussion concerning mic preamps and frontend input interfacing. This step-by-step guide aims to set out the benefits of modifying your Roland VS, and hopefully lay to rest some of the myths surrounding the quest for the 'Holy Grail' in front-end inputs. You won't be hearing any 'rock n' roll' buzzwords like how to how 'warm' a particular op-amp is, or the dreaded, 'the bass sounds tighter'.

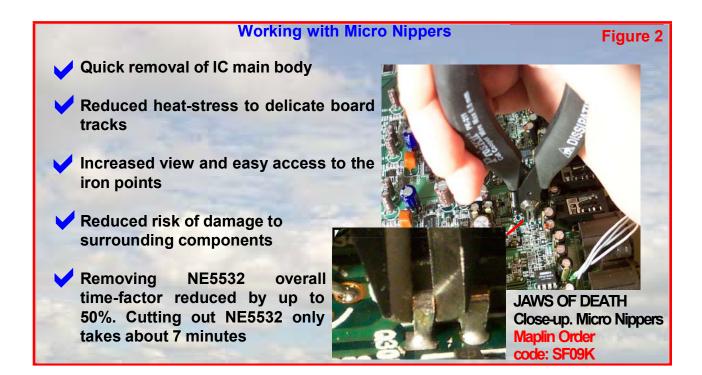
Standard through-board IC removal method working with soldering iron & braid

Cumbersome working in small areas

- X Increased heat-stress to delicate board tracks
- X IC body restricts overall view and easy access to the iron points
- X Risk of damage to board tracks when lifting IC
- X Risk to adjacent surface mount components which are easily dislodged
- X Time consuming. Typically 1.5 hours per IC.

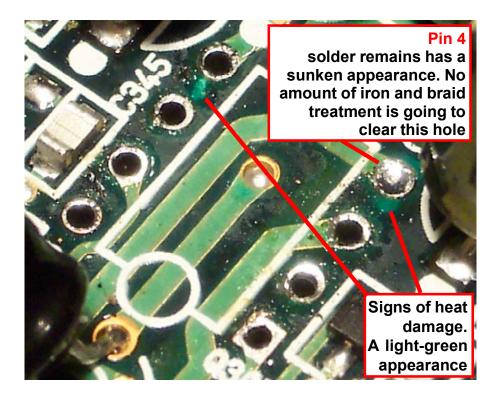
Looking a bit like a battle zone, the cleanup is nearly complete. In the photo, **pin 4** still has a small amount of soldering left in the hole. The light-green appearance on the borders of the hole are tell-tale signs of heat damage. It would be unwise to have another go with the braid and the iron. All is not lost though, as a hand-cranked 0.8mm drill will carefully clear the hole.

0.8mm hand-cranked drill
