Roland VS-1880 op-amp swap

There has been much talk at the VS-PLANET forum about the Roland VS op-amp swap modification, not to mention considerable discussion concerning mic preamps and frontend input interfacing. This step-by-step guide aims to set out the benefits of modifying your Roland VS, and hopefully lay to rest some of the myths surrounding the quest for the 'Holy Grail' in front-end inputs. You won't be hearing any 'rock n' roll' buzzwords like how to how 'warm' a particular op-amp is, or the dreaded, 'the bass sounds tighter'.

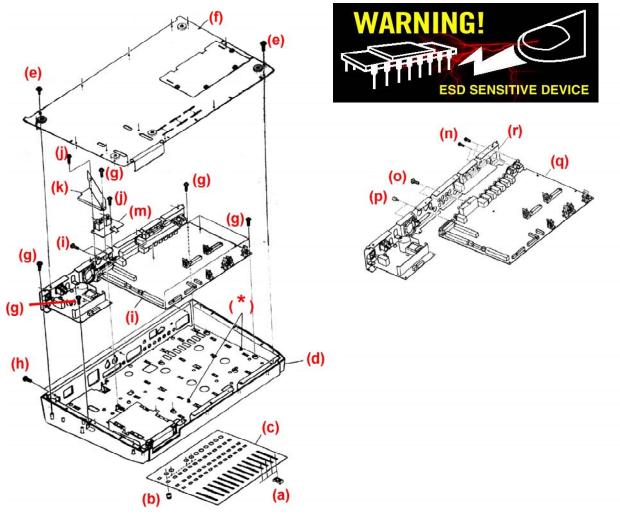
After attaching the top panel A(c), evenly depress the surface using soft cloth for tight

8. Install the repaired or new main board by first engage it with notches (*). Repeat steps 1 to 6 in the reverse order.

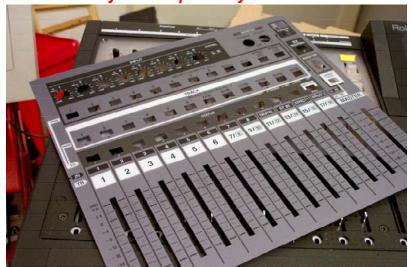
Complete. The only thing to do now is to find a safe dust-free place to temporarily store the sticky panel. *A haystack is probably a bad idea*

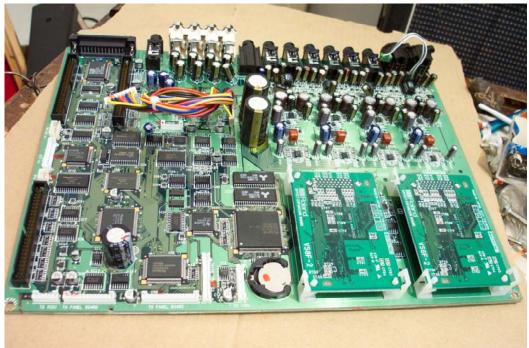
I cannot stress enough the importance and high degree of attention that you must employ removing the main board. It may appear that once you've removed all the relevant screws and auxiliary boards, that one is still having difficulty in separating the main board. Remember, the front/top sticky panel has to be removed first! I tried to remove the board without the removal of the sticky panel, and added at least an hour to my workload! Another point of some confusion was the removal of the power supply and mainboard bracket. These must also be removed, in order for the main board to easily slot out.

Place the main board on a very clean surface. A piece of cardboard is a good idea

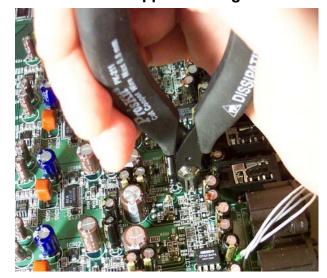
Removing NE5532 Time taken: 7 minutes

Micro Nippers 1st leg

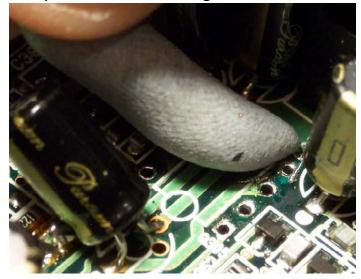
Cleaning up cont'd

IC component side complete, but looking a little bit fluxy. You could use a flux cleaner to give a more pleasing appearance, but there seems little point in doing so.

Opposite side complete with some further heat damage.

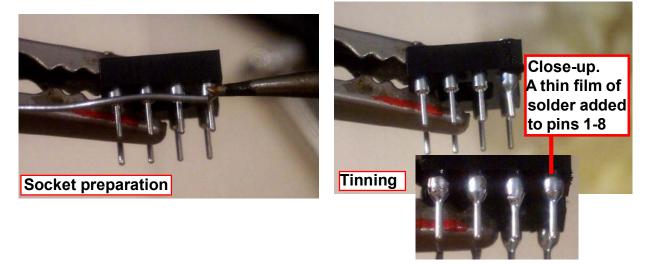
As the IC socket legs must continue through to the opposite side of the board, this can present a significant problem, in gaining access with the iron to the mating points between the socket and tinned tracks. Fortunately all is not lost, as solder thankfully posses the unique properties of capillary reaction. This means that if both the mating areas of the socket and the tracks are sufficiently tinned, when the iron and solder are applied from the opposite of the board, the solder will flow down through the holes, and assisted by gravity/capillary reaction will in turn lead to a good connection *(I need a breather)*.

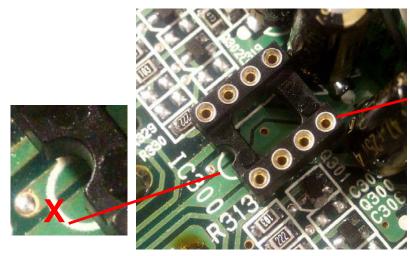
Placing the socket. The little notch in the socket (X marks the spot) should face away from input sockets.

8 pin socket Maplins order code: FZ45Y

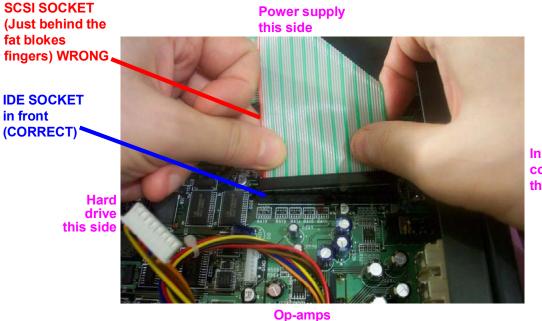
Input connectors this side
